## **Case Study 16: The Upper Kaituna Catchment Control Scheme: has riparian retirement been successful?**

The Upper Kaituna Catchment Control Scheme was developed in the late 1970s to arrest the deteriorating water quality of Lakes Rotorua and Rotoiti, and to do it in part by controlling and preventing soil erosion, sedimentation and nutrient runoff from the surrounding catchment. The other part of the scheme was to reduce the sewage load from Rotorua City entering the lake.

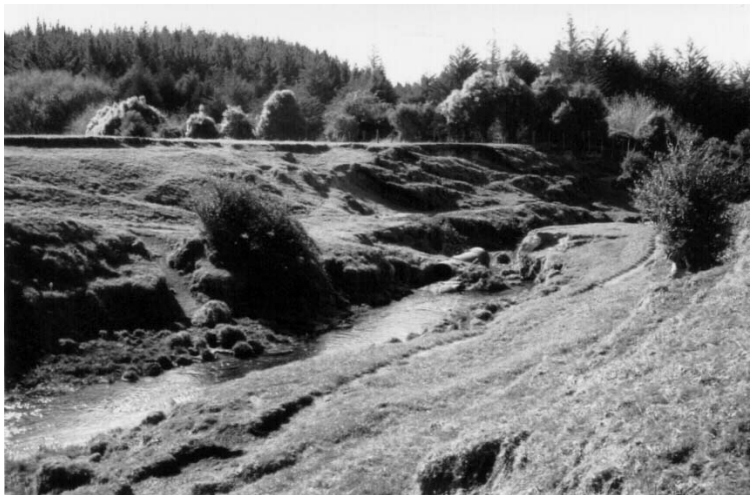
**Photograph 66:** Most of the Ngongataha Stream margins have been retired as part of the Upper Kaituna Catchment Control Scheme. Much of the stream's margins looked like this small unfenced portion prior to the commencement of the scheme. Note the straight stream channel and the unstable steep banks. Compare this to Photograph 63, a reach of the same stream not more than 100 metres away that has been fenced for many years.

Active streambank erosion was found to be occurring on 3.7 percent of a 14.3 km reach of the Ngongataha Stream in a post-retirement survey, compared to 30 percent pre-retirement. In addition, the average size of each erosion site was substantially reduced in the later survey.

The most likely reason for this change is because of the removal of stock and the planting of vegetation that has re-stabilised the banks. An alternative view is that the stream channel has reached a state of equilibrium following the removal of the original stream bank vegetation and its conversion to pastureland, and as a consequence bank erosion is no longer as substantial as it once was.

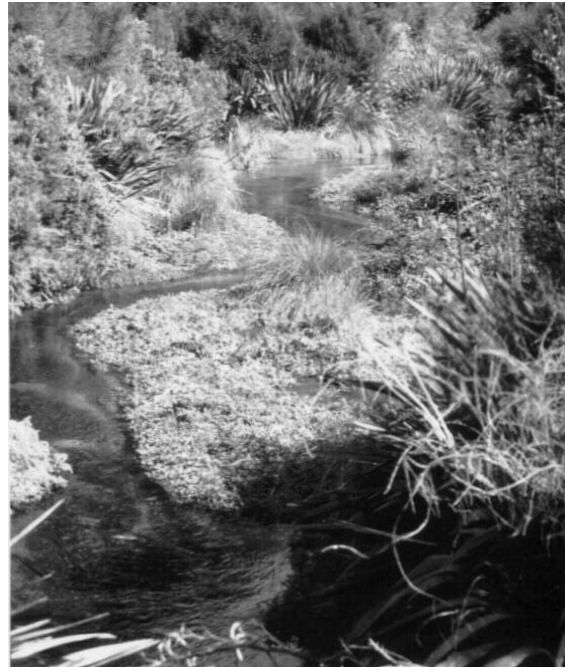
**Photograph 67:** 100 metres along the stream from Photograph 66. Note the wider stream bed and the meandering water channel.
